Board No 1 OCAFF

Communication and Electronics Service Test Division

PROJECT CE 1552

CHART OF FAILURES

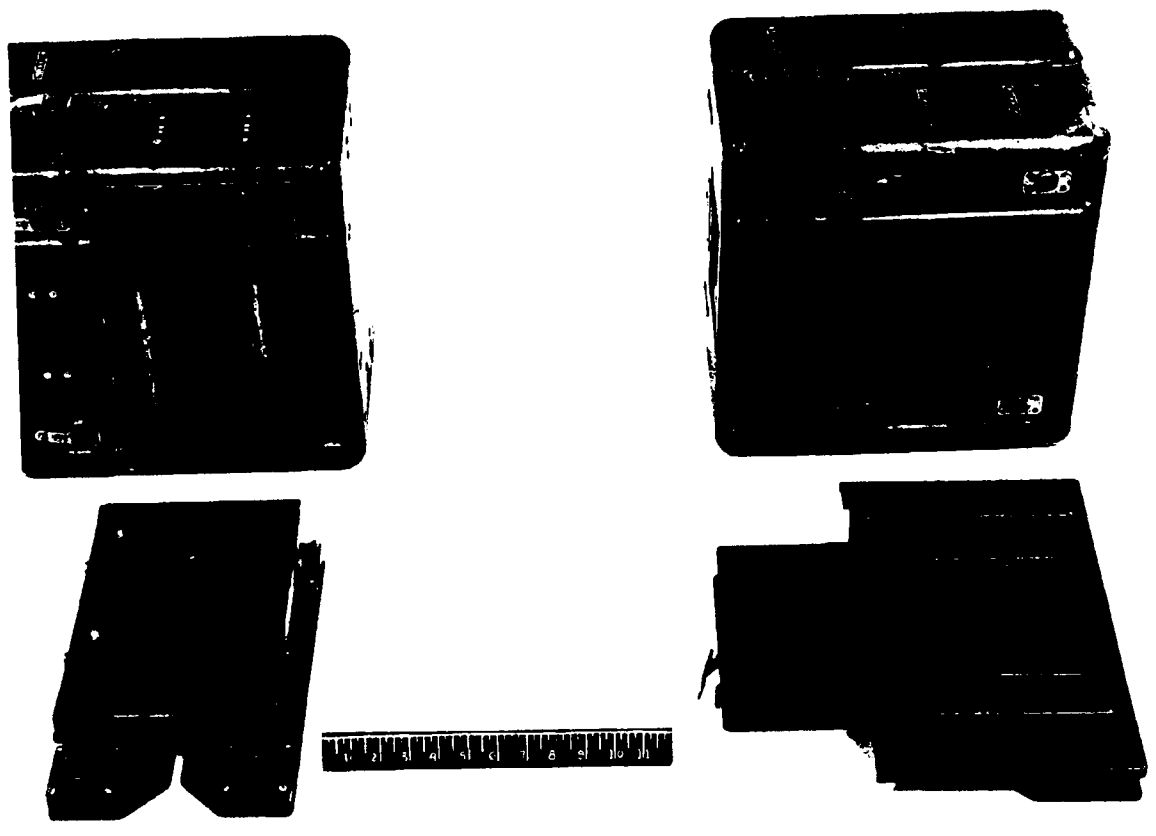
APPENDIX C.6

VEHICULAR MOUNTINGS FOR AFSAM 7

LEFT: CASE, SHOWING CHANNEL MEMBER PLATE ADDED LOCALLY TO ENABLE USE OF STANDARD TYPE MOUNTING MT-791/U

RIGHT: CASE WITH FITTINGS, AND SPECIAL MOUNTING BASE SUPPLIED WITH AFSAM 7

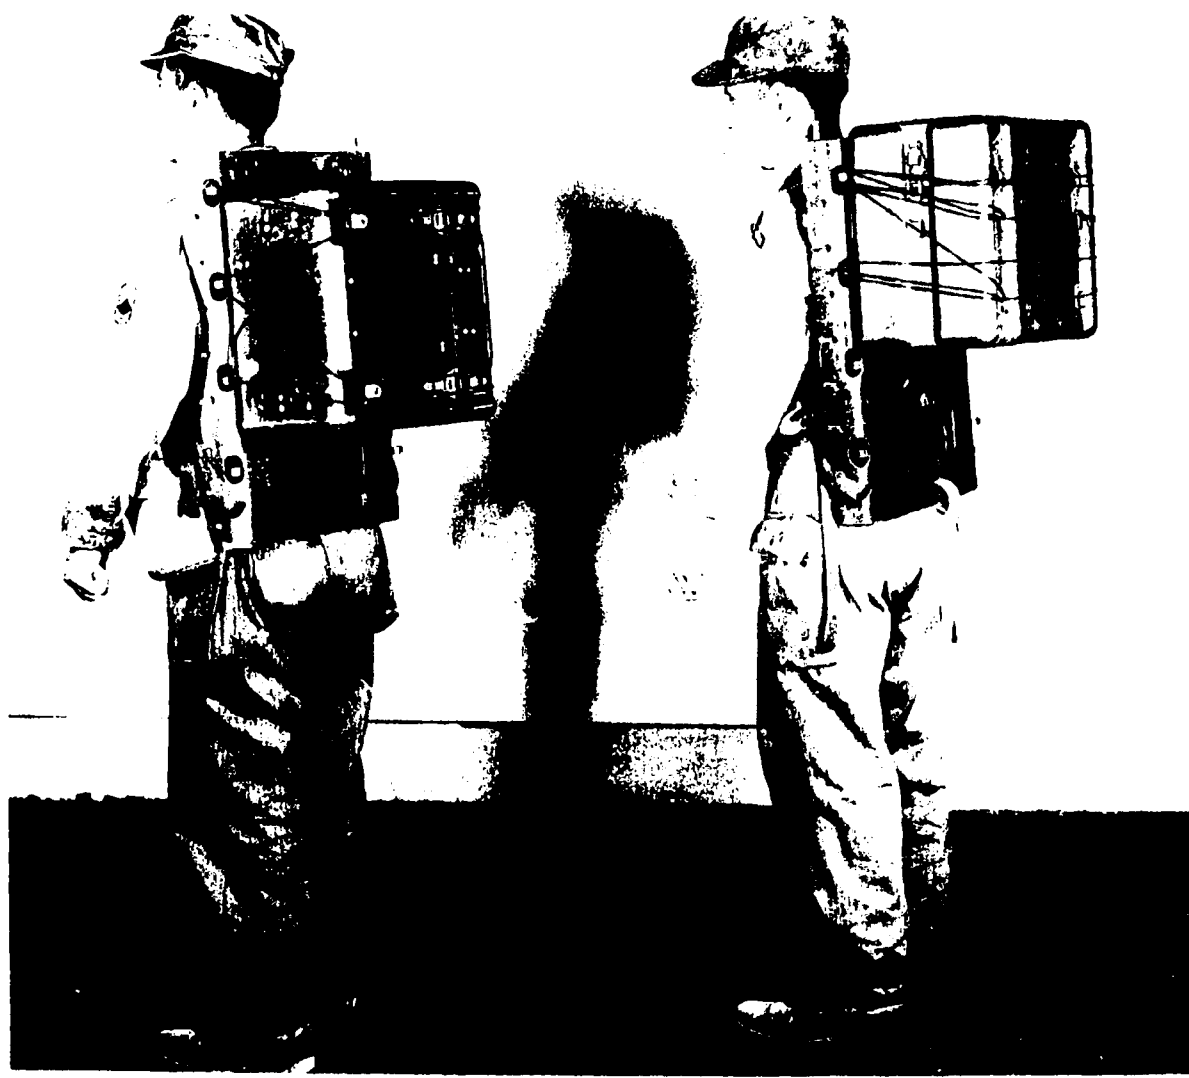
APPENDIX C.9

AFSAM 7 PREPARED FOR MANPACK

LEFT: UNBALANCED LOAD, USING PRESCRIBED MOUNTING ARRANGEMENT
 RIGHT: METHOD OF TYING AFSAM 7 TO PACKBOARD TO PROVIDE A BALANCED LOAD

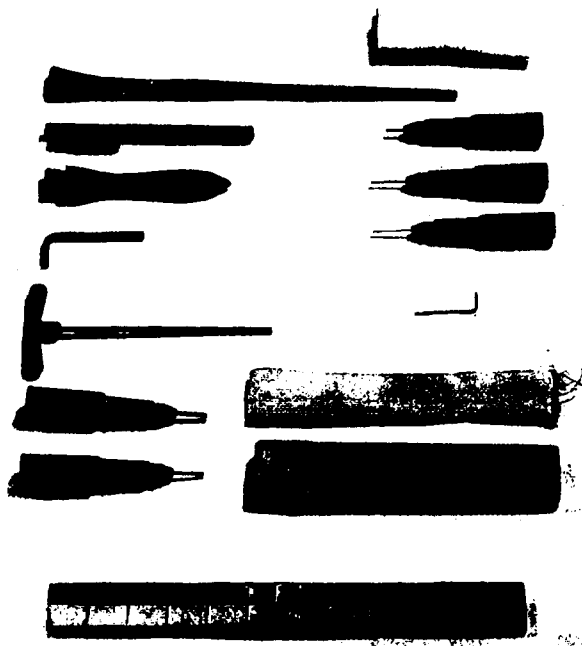
APPENDIX C.10

CLEANING MATERIALS AND TOOLS PROVIDED FOR FIELD MAINTENANCE OF AFSAM 7

The cleaning material and tools provided for maintenance of AFSAM 7 during service test are shown in Appendix C.10. Under present maintenance policy, the cleaning materials, only, were available to the operator for first echelon maintenance. Field maintenance personnel will have the wrenches shown for sub-assembly replacement. Maintenance of subassemblies is to be performed by ASA personnel in communication reconnaissance groups and battalions at army and corps level, respectively. "Special Tools" in Column 6 of the following chart pertain to items not included in the field maintenance items furnished with AFSAM 7 for service test (Appendix C.10).

AFF suggested modification: Provide accessory case; tube puller, tube pin straightener; tape moistening tool, equivalent to Western Union tool or Teletype No. 70169 Tape Moistener, with cutter, tape, thimble, Size No. 9, Teletype No. 72638; ruby eraser for cleaning rotor contacts.
